# Manhole Inspection Summary

Manhole # S47A\_\_027MH

Insp Date: **6/11/08 10:46 AM**

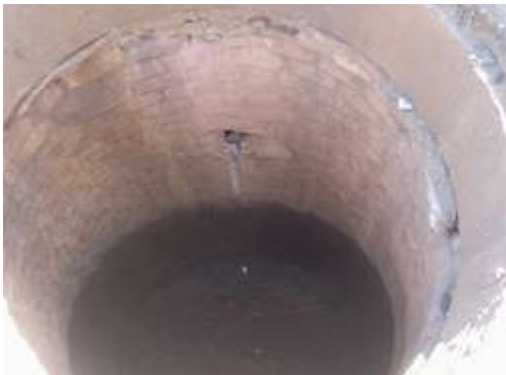
Defect 1

loose bricks

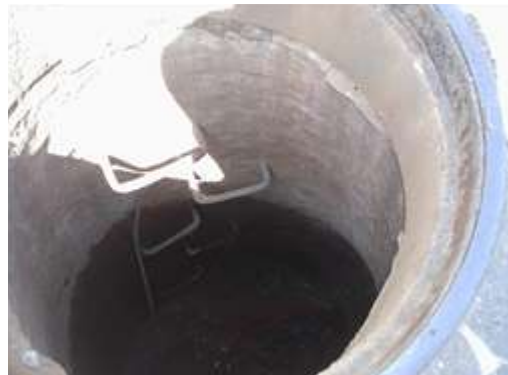
Defect 2

Offset: **1** (in.)

offset frame

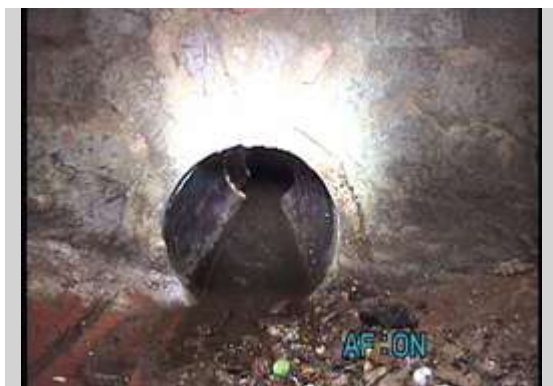
12 O'Clock Outflow

8 in. Circular Gravity Sewer  
Pipe Out @ 12 O'Clock

Infiltration: **None** Pipe Seal Cond: **Sound**
